Mount Marrow

Mine Remediation Trial on the Caledonian No.3 Colliery in Mt Marrow, QLD.

PROJECT OVERVIEW

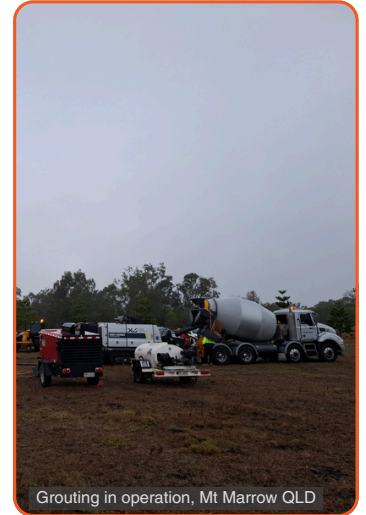
Grouting in operation, Mt Marrow QLD

Borehole BH4 was selected as the grouting trial location, being the deepest borehole with the most clearly confirmed void and rubble condition. One truck load of 5 MPa readymix grout (6 m³, mix code DGS55270, 270 mm slump) was placed via tremie through the drill casing. The full 6 m³ load was discharged without a measurable pressure increase at the pump, confirming the void at BH4 accepted the full volume and that significant unfilled void space remains within the collapse. Casings were subsequently extracted and the borehole grouted to ground level.

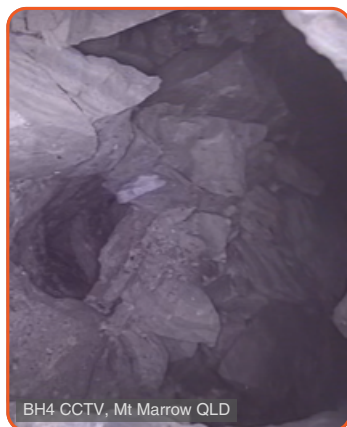
BH4 CCTV, Mt Marrow QLD

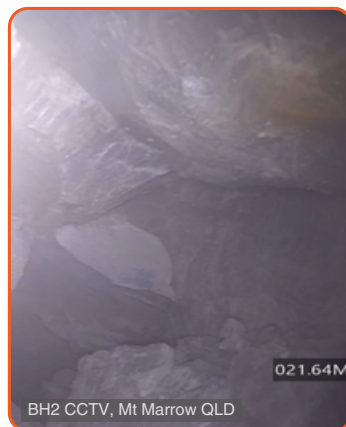
BH2 CCTV, Mt Marrow QLD

CCTV camera inspection was conducted in all six boreholes following drilling to directly confirm the presence and extent of voids within the collapsed mine workings. Footage confirmed open void conditions in three of the six boreholes drilled: BH1 and BH2 each revealed voids of 0.25 m and 0.5 m respectively within collapsed rubble at depths of approximately 21 to 22 m, while BH4 exposed an 0.8 m void blocked by timber and collapse debris at 25.8 m depth. The remaining three boreholes showed fully collapsed rubble without visible open void, which DGSA considers consistent with possible pillar interception given the imprecision inherent in historical mine plan overlays. Six UCS specimens were cast from the trial grout placement at BH4 for 7-day and 28-day testing to confirm grout mix compliance.
