# Trevis Court

Underground Mine Remediation with Grout Block Construction for a residential development at Blackstone, Queensland.

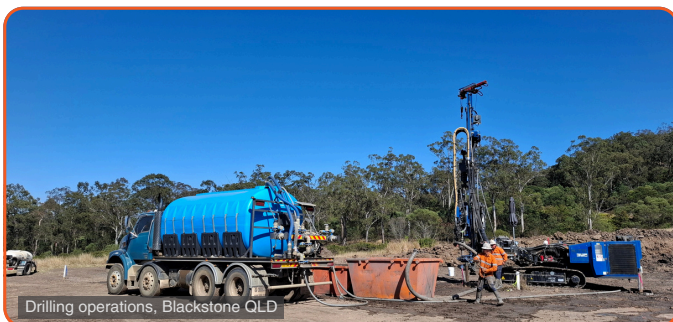
Drilling operations, Blackstone QLD

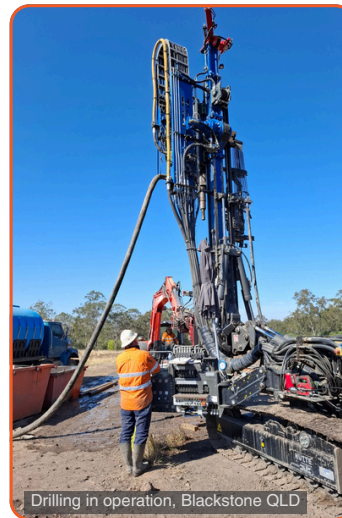
Drilling in operation, Blackstone QLD

DGSA provided a full design and construct mine remediation solution, including geotechnical design in conjunction with the Engineer of Record, Steve Ditton of Ditton Geotechnical Services. Nine grout holes were drilled along the central alignment of the tunnel at approximately 6m centres, covering the full 40m section of mine workings identified as requiring treatment. All holes were drilled using a 114mm casing shoe with water flush, with each hole logged and camera-inspected where conditions permitted.

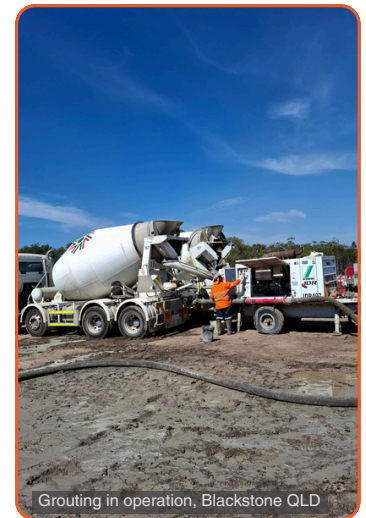
Grouting in operation, Blackstone QLD

Collapsed mine working voids were encountered at all hole locations, with void roof depths ranging from 7.5m to 14m and void heights of 2.5m to 6m. Grout was placed by tremie pump through the installed casings directly into the collapsed zone, with casing lifted in stages to achieve full void infill and grout return to surface. A total of 52.4 m3 of grout was installed across the nine holes. Connectivity between adjacent holes was confirmed during grouting operations, with grout water and grout overflow observed at neighbouring casings during active pours, providing positive evidence of void infill and lateral grout spread between holes.

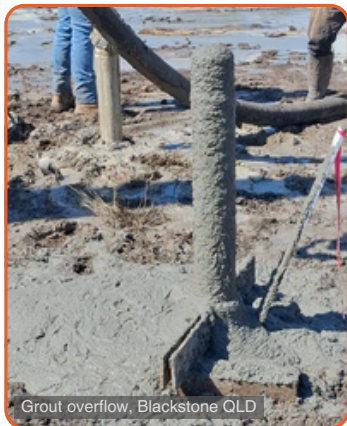
Grout overflow, Blackstone QLD

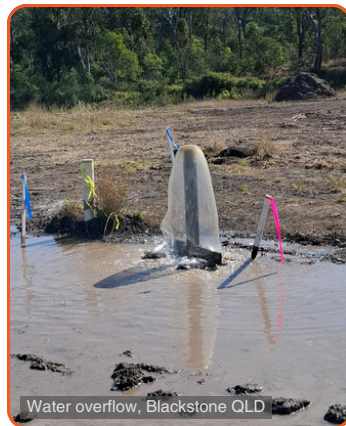
Water overflow, Blackstone QLD
