Briswest Precinct 6

Underground Mine Remediation with Grout Cone Construction for a major industrial precinct development at Swanbank, South East Queensland.

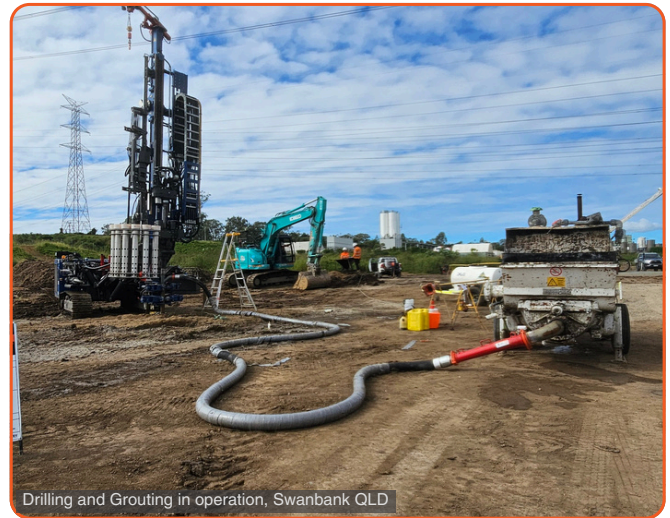
Drilling and Grouting in operation, Swanbank QLD

The construction sequence for each cone was as follows: a 114 mm cased borehole was drilled from the surface to 1 m below the mine working floor using a Hutte HBR605 drill rig; a borehole camera confirmed the void geometry and condition; aggregate (crushed gravel) was then placed through the casing to the floor of the working, and cement grout was pumped to bind the aggregate and make contact with the mine roof, forming a cone with an angle of repose of approximately 20 degrees in the flooded workings. Three dedicated monitoring holes were installed to allow camera verification of cone geometry and roof contact following each pour. Grout was supplied by ready-mix agitators to the concrete pump during peak production phases and supplemented by an on-site ICB mixer.

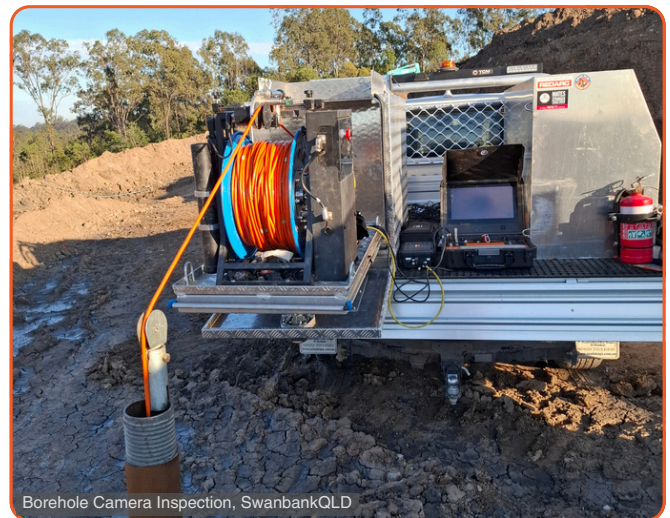
Borehole Camera Inspection, SwanbankQLD

DGSA successfully completed all 12 grout cones across Briswest Site 6, eliminating the identified sinkhole risk and satisfying the geotechnical conditions required for Rogan Development Solutions to proceed with permanent warehouse and hardstand construction. Camera verification confirmed roof contact at each cone location. The project was delivered with zero recordable safety incidents. On completion, all plant was demobilised from Site 6 and DGSA mobilised directly to the adjacent Site 4 works, continuing DGSA's programme of mine remediation across the broader Briswest industrial estate.
